# **Experimental Fire Tests of Two-Way Concrete Slabs**

**University of Canterbury  
Fire Engineering Research Report 02/12**

**September 2002**

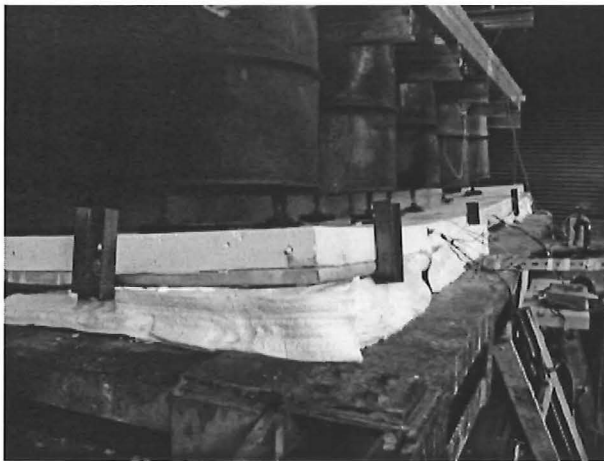
After 15 minutes into the tests, the corners of the slabs started to curl upwards noticeably (Figure 6-2). Mineral wool was used to cover these openings to prevent the gases from escaping. Cracking at the top of the slab soon followed the curling of the slab corners. The first cracks appeared in the middle of the slab, running in the transverse direction. Water and steam then started to seep through cracks. The curling of the corners of the slab caused the water to accumulate in the middle of the slab, forming a large puddle (Figure 6-3). Water also accumulated in the recesses of the lifting inserts, which eventually boiled and evaporated. The cracks on the unheated side did not penetrate the full depth of the slab. Had a full depth crack formed in the middle of the slab, the water would seep through and flames would have passed through the cracks.

**Figure 6-2: Curled corners of the slab.**

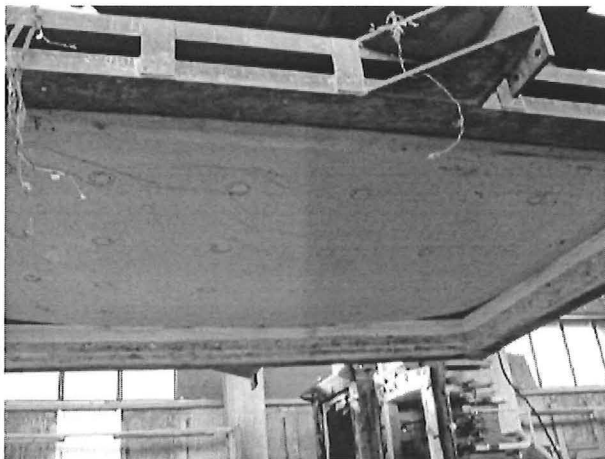
**Figure 6-13: Underside of the slab after the fire test.**

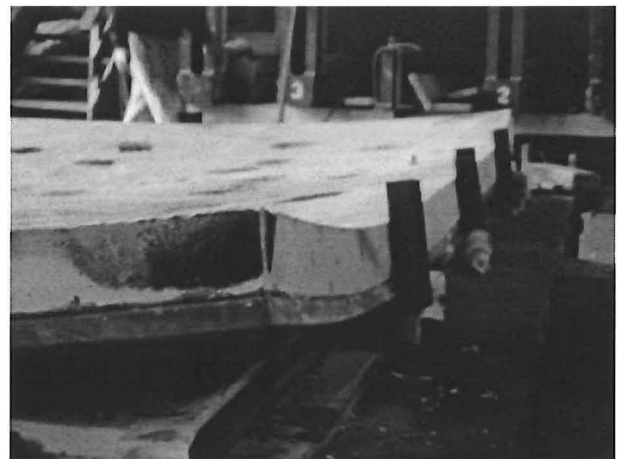
**Figure 6-14: Deflection of the edges of the slab.**

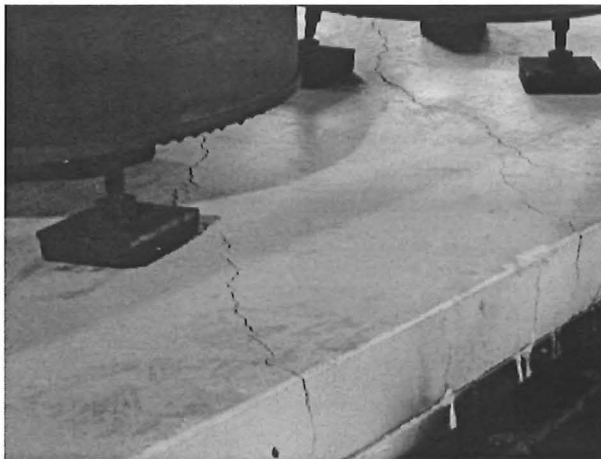
**Figure 6-24: Diagonal cracks at the corners extending to full depth cracks at the sides of the slab.**

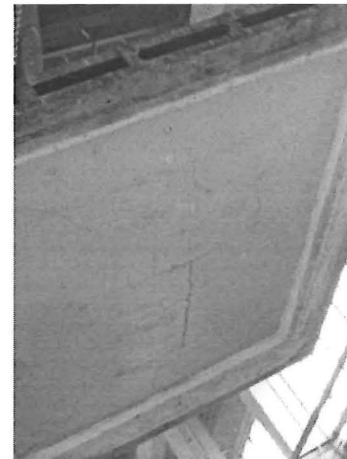
**Figure 6-25: Underside of the slab after the fire test, showing the yield line cracks.**

Figure 6-25 shows the bottom of the slab and the deformed shape immediately after the fire test, respectively. Figure 6-26 shows the deformed slab after the test. On the top surface, the white paint had discoloured and became brown. Figure 6-27 and Figure 6-28 show that three large cracks formed across the transverse direction of the slab. These cracks were spaced at 600mm apart, equivalent to two grid spacings of the mesh. One full depth crack formed in the longitudinal direction at the centre of the slab. This full-depth crack is approximately 1200mm long. Surface cracks formed in a circular pattern around these large central cracks. Large cracks also formed in the longitudinal direction, located approximately 200mm from the edges of the slabs. In spite of cracks as wide as 10mm on the top surface, flames did not pass through the cracks, which would have caused integrity failure.

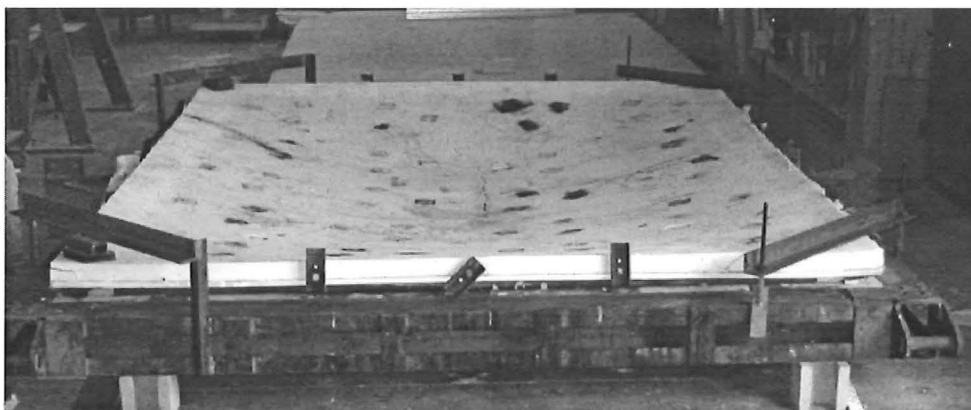
**Figure 6-26: Deformed slab after the test.**

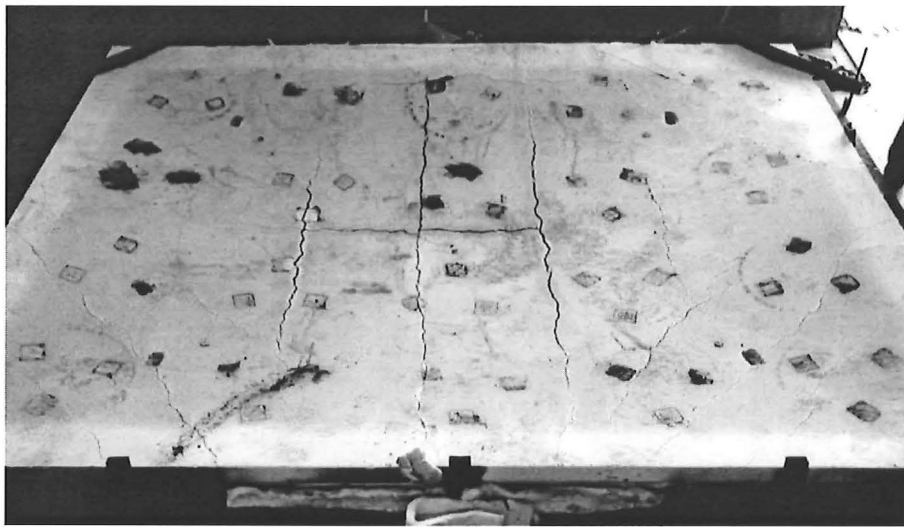
**Figure 6-27: Crack pattern at the top surface of the slab.**

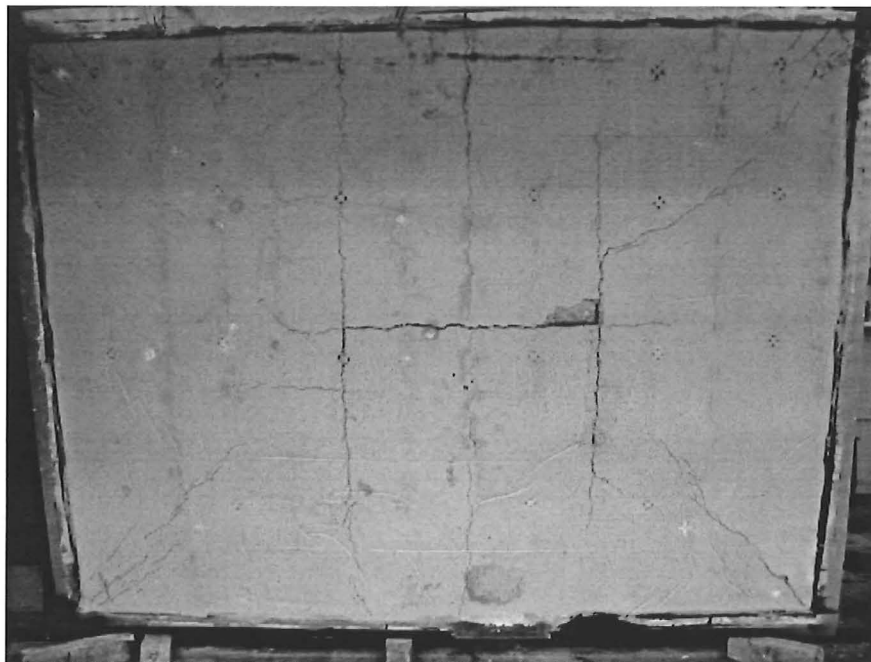
underside of the slab. Figure 6-28 shows that a small portion of the bottom surface cover near the centreline had fallen off. This occurred after the slab had cooled down and was not due to spalling. The large surface crack in the longitudinal direction had extended to its full depth and was clearly seen on the bottom surface of the slab. Two large full depth cracks which propagated in the short span could also be clearly seen at the bottom of the slab. A finer crack also formed in the middle of the slab, between the larger full depth cracks. This crack had closed up when it was examined the following day and corresponds to the large crack on the top surface. In addition to the transverse, fine diagonal cracks running at 45 degrees from the corners towards the centre region of the slab could also be seen. After the slab was broken, examination of the reinforcing bars showed that the bars in the slab had not ruptured across the full depth cracks during the fire.

**Figure 6-28: Crack pattern at the bottom surface of the slab.**

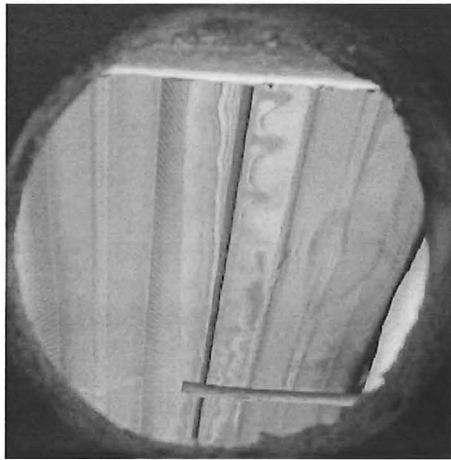
**Figure 6-32: Buckling of the steel decking during the fire, seen through the east viewing port.**

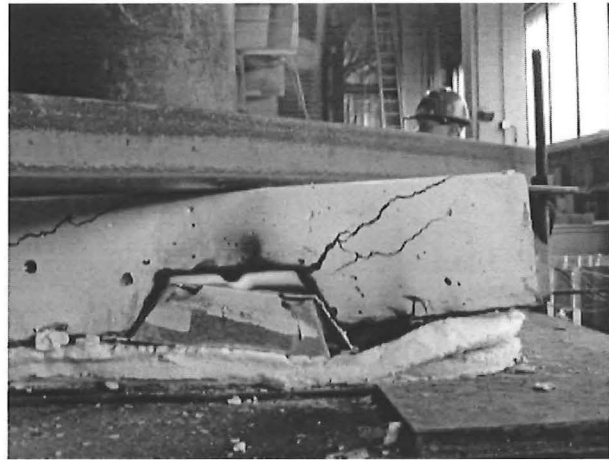
**Figure 6-33: Debonding of the steel decking and diagonal cracks forming at the rib-slab intersection.**

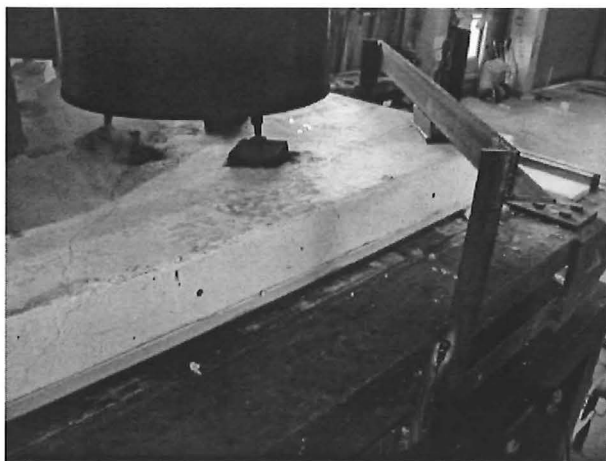
**Figure 6-34: Steam seeping through the diagonal cracks at one of the corners of the Hibond slab. The crack had extended the full depth of the slab.**

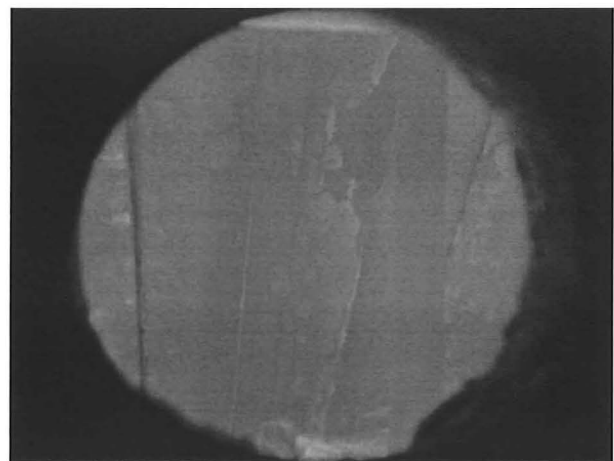
Cracks appeared at an early stage at the top of the slab at midspan, running in the transverse direction of the slab and diagonally, where the corners of the slab were clamped down (Figure 6-34). Similarly with the other tests, there was a lot of steam and water seeping out of the cracks. After 1 hour 20 minutes, the diagonal and horizontal cracks at the top surface had widened significantly but had not allowed the flames to pass through the openings. After 2 hours and 30 minutes, blisters started to appear beneath the steel decking (Figure 6-35). The blisters formed when the galvanizing of the steel oxidised.

**Figure 6-35: Severe blistering of the steel decking due to oxidation.**

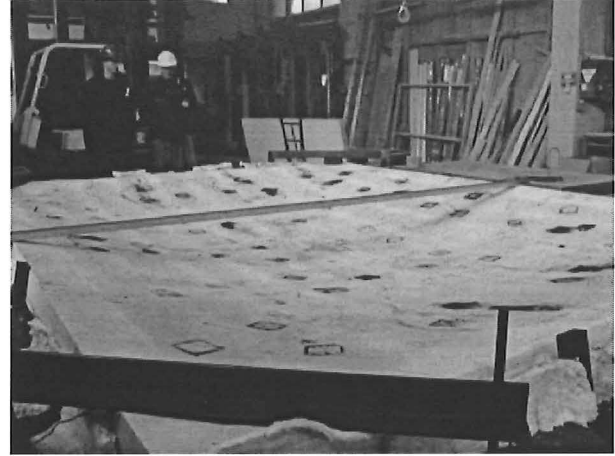
**Figure 6-36: Hibond slab being lifted off the furnace.      Figure 6-37: Deflected slab after the fire test.**

Figure 6-37 shows the large deflections in the Hibond slab after the fire test. Figure 6-38 shows a large crack (up to 9mm wide) had formed across the middle of the slab in the longitudinal direction. The slab also had a series of horizontal cracks running across the short span at regular parallel spaces. The cracks were spaced at 300mm apart which corresponded to the position of the bars of the reinforcing mesh. The diagonal cracks which formed at the corners were also spaced at regular intervals.

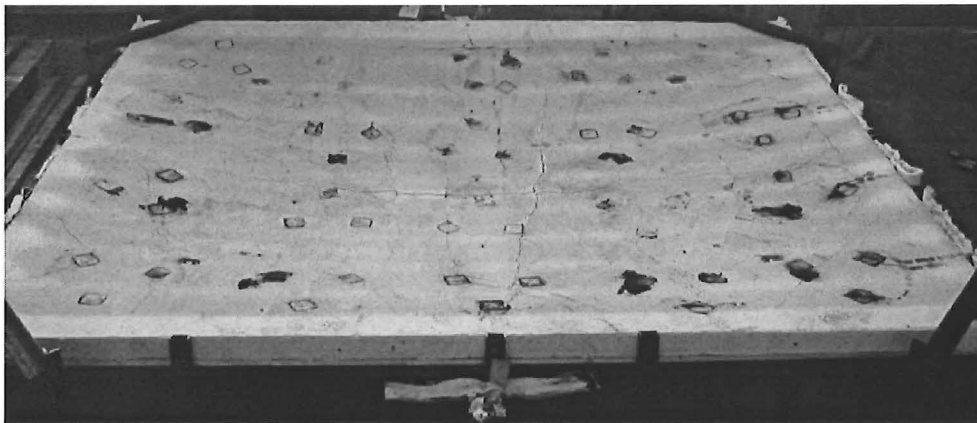
**Figure 6-38: Deformed Hibond slab after the fire test.**

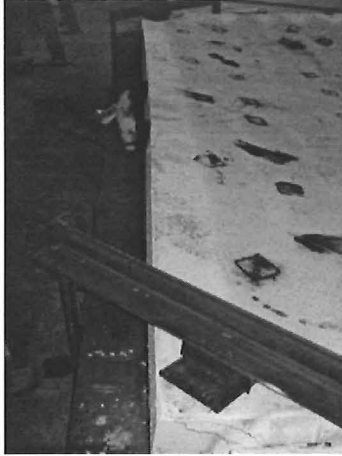
Figure 6-39 shows that the centre region of the sides of the slab had deflected inwards, relative to the corners of the slabs. The large midspan deflections had caused the centre regions of the sides to contract and deflect inwards. Figure 6-40 shows a large amount of concrete had spalled off the ribs of the slab when the steel decking was pried from the slab. The steel decking held the concrete in place, preventing it from falling off the slab and exposing the reinforcing steel.

**Figure 6-39: Inward deflection of the centre regions of the sides of the slab.**

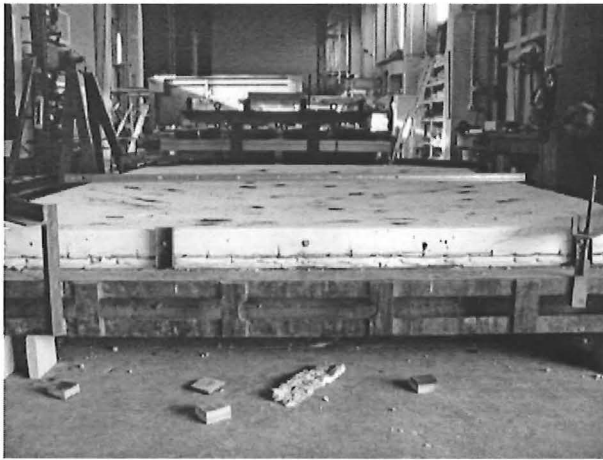
**Figure 6-45: Deformed shape of the slab after the test.**

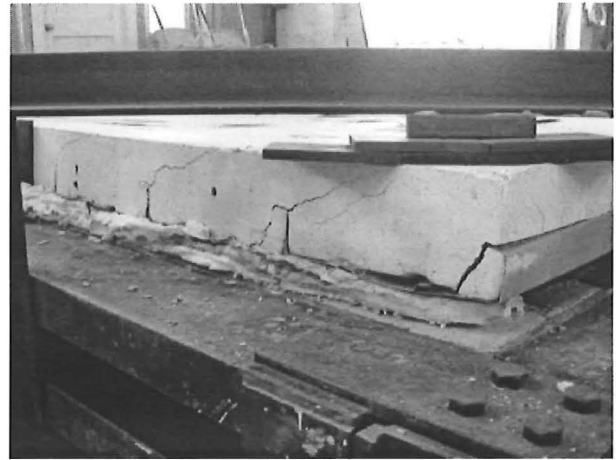
**Figure 6-46: Diagonal cracks at the edges of the slab.**

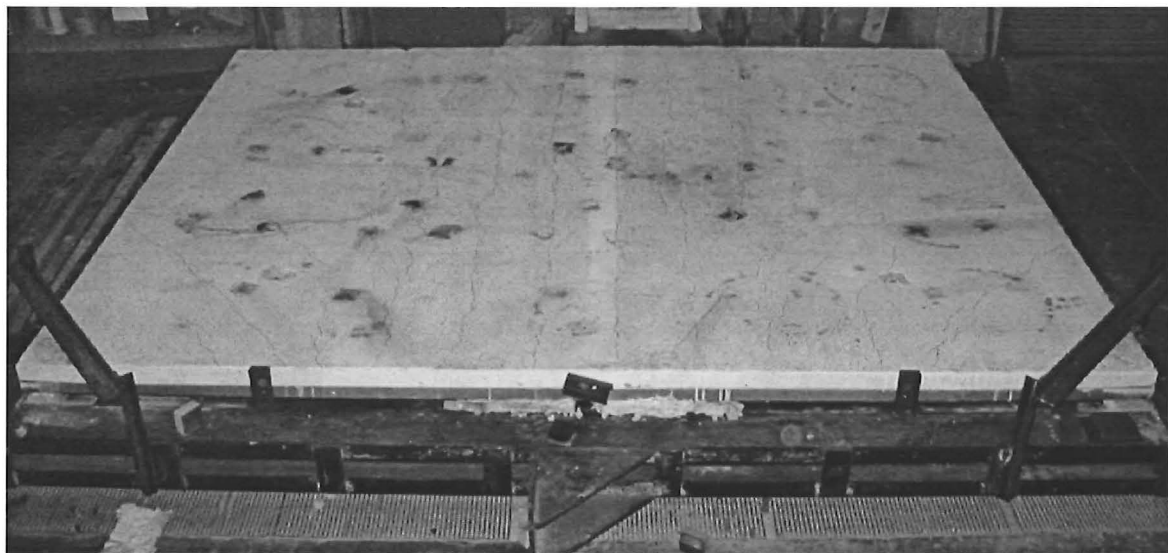
cracks running in the transverse direction at the top of the slab, spaced at 300mm centres (Figure 6-47). Compared to that seen in the third and fourth tests, this slab had fewer diagonal cracks and the widths of its surface cracks were generally much smaller.

**Figure 6-47: Top view of the Traydec slab.**

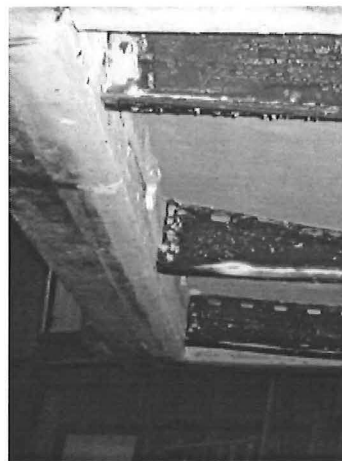
At the end of the test (3 hours), the slab had deflected to -180mm at midspan. When the slab was lifted from the furnace, the steel joists were glowing pink (Figure 6-57) and the surface of the joists suffered extensive oxidisation. The centre joist had buckled very severely while the joists closer to sides showed less deformation. Figure 6-58 shows the ends of the joists near the face of the concrete beam. The bottom flanges of the joists did not butt up against the concrete beam, shown by a 10mm gap between the bottom flange of the joist and the vertical face of the concrete beam. The web of one of the side joists had expanded and butted up against one of the steel plates which supported the rollers. This formed a notch at the top of the web.

**Figure 6-58: Extensive oxidization and buckling of the steel joists.**

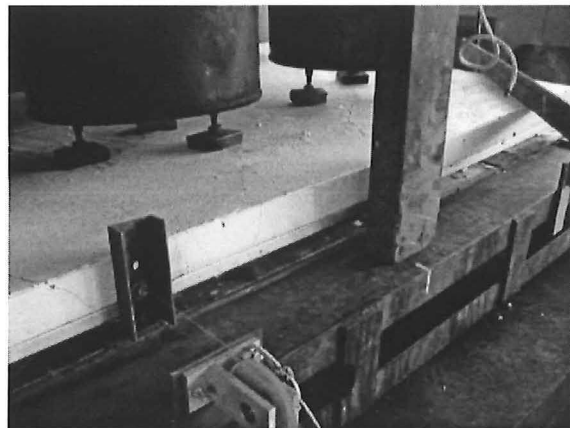
**Appendix Fig. 71: Corner cracking of the slab during the fire test.**

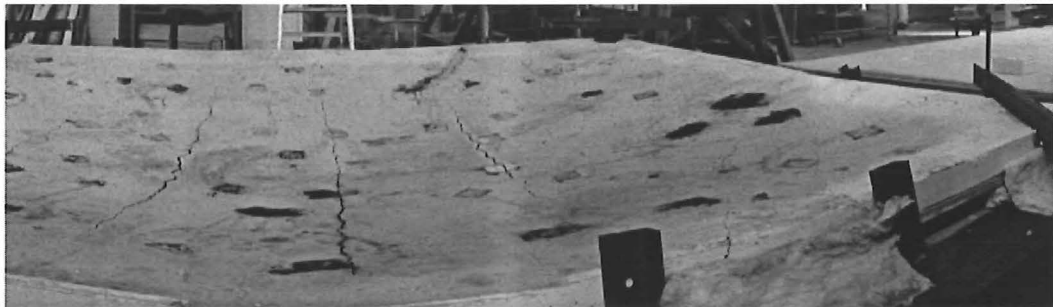
**Appendix Fig. 74: View of the large surface cracks immediately after the fire test.**

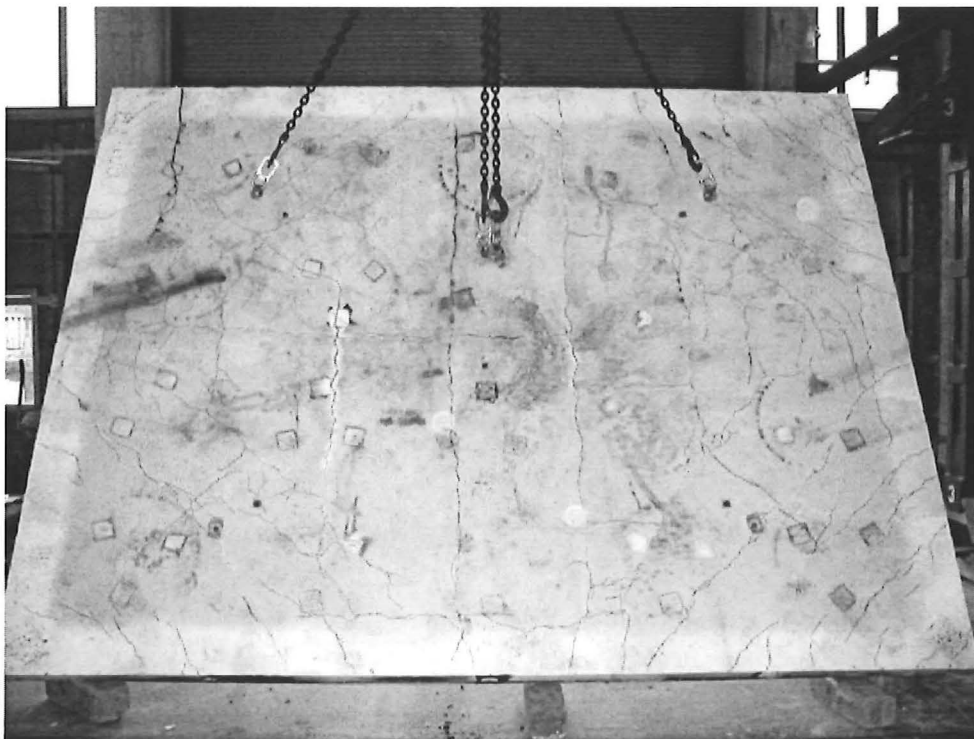
**Appendix Fig. 75: Crack pattern of the top surface of the slab.**

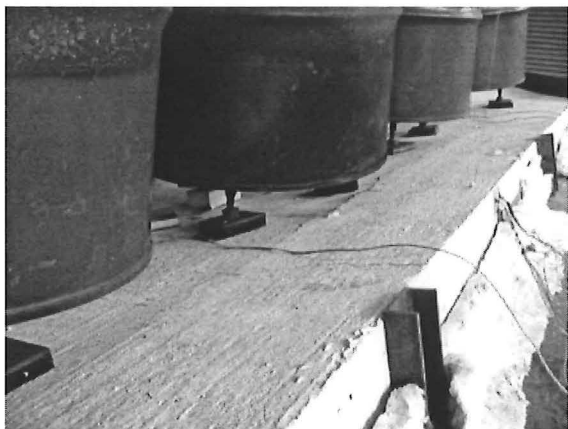
**Appendix Fig. 78: Large surface crack in the longitudinal direction near the slab supports.**

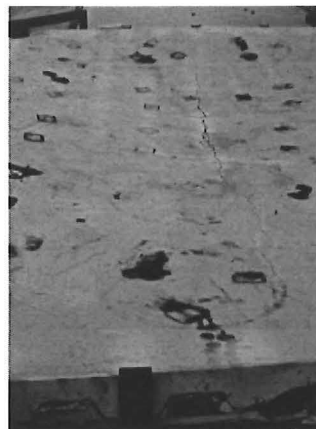
**Appendix Fig. 79: Large surface crack in the longitudinal direction in the middle of the slab.**

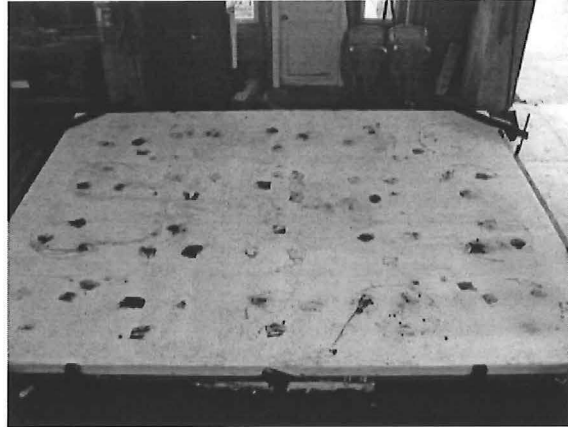
**Appendix Fig. 83:** Top view of the slab after the fire test, showing only small surface cracks.
